Response to the coroner's recommendations (court ref: COR 2014 006579)

ROAD SAFETY INSPECTION REPORT OF APPLETON DOCK ROAD, NEAR THE INTERSECTION WITH ANDERSON ROAD, WEST MELBOURNE

DATE:
11th September 2017

ROAD SAFETY INSPECTION (AUDIT) TEAM:
Phillip Jordan – Senior Road Safety Auditor
Daniel Mustata – Senior Road Safety Auditor

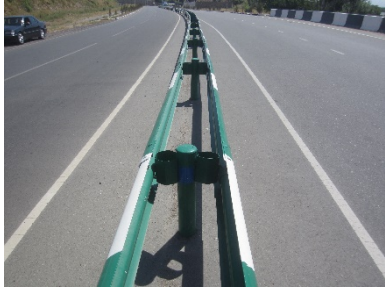
NO.	SAFETY CONCERN	RISK	PHOTO	RECOMMENDATION	CLIENT RESPONSE
ROAD SAFETY INSPECTION RESPONSES TO THE CORONERS SUGGESTIONS					
1	The installation of a barrier (rigid, semi-rigid or flexible) is not supported along Appleton Dock Road. It would prevent U-turns but it would also restrict crossing opportunities for pedestrians. It would likely be subject to "innocent" hits by trucks and it would reduce the available cross section of the road, especially for turning long vehicles. Providing safe terminals at each driveway gap would present additional technical challenges.	NOTE

<ul style="list-style-type: none"> - Do not install barrier along Appleton Dock Road. - Instead, install a physical median as recommended in 2 and 3 (below) 	Installation of any permanent infrastructure will become redundant as there are road closures foreshadowed to take effect in early 2018. Appleton Dock Road south of Anderson Road intersection will be closed and absorbed into a port tenancy.

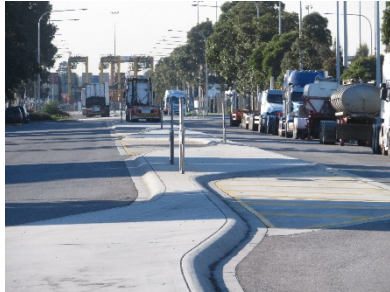
2	This central median in Mackenzie Road helps to separate both directions of traffic and prohibits U-turns. It appears to be serving a useful purpose, and it offers an idea of what a median in Appleton Dock Road could look like. It offers a refuge for any crossing pedestrians. Illegal parking by one truck was observed on the median. This is a sign of the need for increased parking enforcement. A parking review is recommended.	NOTE

<ul style="list-style-type: none"> - Use this median as a template for the design for a similar median in Appleton Dock Road. - Install the median from a point at the traffic signals at Coode Road along the road to the informal turning area at the southern end of the road. - Leave gaps for key driveways and intersections. - Consider offsetting the median to the east of the centre line to accommodate (if necessary) double parking by trucks along the western side. 	Installation of any permanent infrastructure will become redundant as there are road closures foreshadowed to take effect in early 2018. Appleton Dock Road south of Anderson Road intersection will be closed and absorbed into a port tenancy.

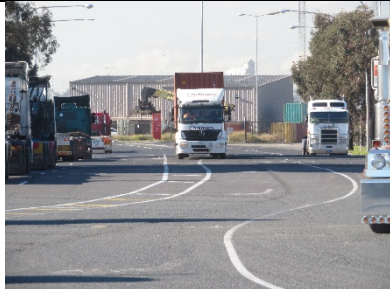
3	A central median along Appleton Dock Road will reduce the ability for long trucks to make U-turns. It can be designed to permit turns into/out of driveways by long vehicles while also permitting a single lane of traffic in each direction.	NOTE

<ul style="list-style-type: none"> - Construct a central median along Appleton Dock Road between Coode Road and the informal U-turn area at the southern end. 	Installation of any permanent infrastructure will become redundant as there are road closures foreshadowed to take effect in early 2018. Appleton Dock Road south of Anderson Road intersection will be closed and absorbed into a port tenancy.

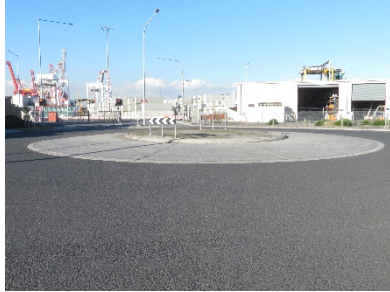
NO.	SAFETY CONCERN	RISK	PHOTO	RECOMMENDATION	CLIENT RESPONSE
4	This is an example of a roundabout in the port area. It received very limited traffic use during the inspections. It should be questioned whether this treatment could be justified on cost grounds for these observed traffic volumes. Other lower cost forms of intersection control are available; retaining the present traffic control at the Appleton Dock Road/ Anderson Road intersection is therefore recommended based on this observation.	NOTE

<ul style="list-style-type: none"> - Retain the Stop sign control at the intersection of Appleton Dock Road and Anderson Road. - Note that roundabouts are a safe form of intersection control. They require balanced traffic flows to function at their best. They are also expensive, and thus they are usually installed in locations with higher volumes of traffic than at the Anderson Road intersection. (See point 2.4.2 above) 	Agreed. The Stop Sign control at the intersection of Appleton Dock Road and Anderson Road will be maintained.

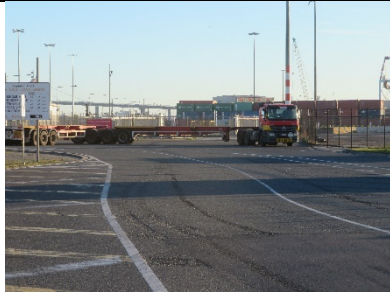
5	The informal turning area at the southern end of Appleton Dock Road is adequate at present. Channelizing it, or constructing a roundabout at this location, is unlikely to improve safety or efficiency.	NOTE

<ul style="list-style-type: none"> - Widen the paved area and remove the corporate direction sign near the railway crossing to facilitate easier turns. - Reinstate line marking to make clear that this is a turning area. - Confirm that adequate numbers of No Standing Anytime signs are installed around the perimeter. 	Installation of any permanent infrastructure will become redundant as there are road closures foreshadowed to take effect in early 2018. Appleton Dock Road south of Anderson Road intersection will be closed and absorbed into a port tenancy.
SPECIFIC ROAD SAFETY ISSUES IDENTIFIED DURING THE INSPECTION					
1	These "corporate" direction signs are difficult to read and offer little useful information to drivers in a form they can readily use. The colours and the fonts and font size are not standard for direction signs. It is possible that a driver may not see or may not appreciate that these are the necessary direction signs for the port area. In such cases the driver may make an error which could lead to incidents	LOW

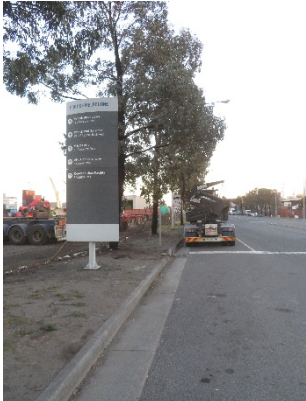
- 2.3.12 The corporate style direction signs are difficult to read due to their colour (grey and white) and the font type/size. They are ineffective and should be replaced with direction signs that conform to AS1742.2.

<ul style="list-style-type: none"> - Replace these "corporate" direction signs with standard "white on green" direction signs with standard fonts and sizes 	Agreed

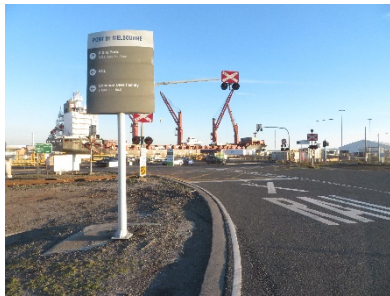
<ul style="list-style-type: none"> - Review the maintenance regime for the street lights and ensure that the lights are operational. 	Agreed
3	This corporate direction sign has the same deficiencies as the sign reported earlier (See 1). In addition, this sign post is a roadside hazard (too close to the road) and it is placed in a position which restricts drivers who are turning at the end of Appleton Dock Road	LOW

<ul style="list-style-type: none"> - Remove this sign. - Pave the area below and surrounding this sign to provide a larger and easier turning circle for trucks making U-turns near here. 	Installation of any permanent infrastructure will become redundant as there are road closures foreshadowed to take effect in early 2018. Appleton Dock Road south of Anderson Road intersection will be closed and absorbed into a port tenancy.

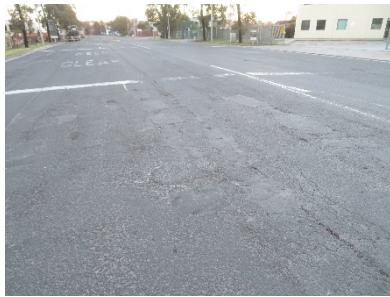
- 2.3.8 The pavement of Appleton Dock Road on the south side of the intersection is becoming rough and worn. These areas may be unsettling for a motorcyclist or a bicyclist (but none of these road users were noted during the inspections). The pavement needs to be investigated and assessed for renewal.

4	Some small areas of the surface of Appleton Dock Road is showing signs of spalling, particularly just north of Anderson Road. This is not likely to present a road safety problem but it is a sign that maintenance of the pavement will be necessary soon.	LOW

<ul style="list-style-type: none"> - Investigate and assess the most suitable action to aid the longevity of this surface. 	Agreed and completed September 2017

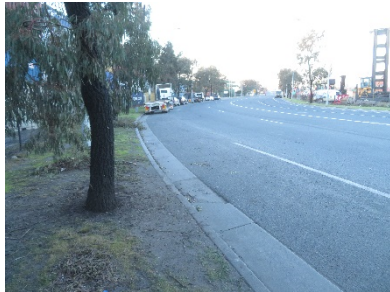
NO.	SAFETY CONCERN	RISK	PHOTO	RECOMMENDATION	CLIENT RESPONSE
5	Within the recommended 3m clear zone there are some trees and some light poles. In view of the width of this road, and the parking that takes place for much of the time, it is suggested that these hazards are sufficiently far from the main traffic paths that they present a very low risk to a reasonable road user. However, good quality line marking is recommended to help drivers to remain in the correct path.	LOW

<ul style="list-style-type: none"> - Re line mark the road. - Do this after a decision is made about the central median in this road. 	Agreed
6	The parking signs need to be reviewed. They are confusing and may not be enforceable under the Victorian Road Rules 2009. Standing has a different meaning to Parking.	LOW

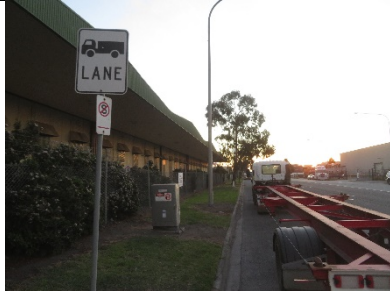
7	It is unclear what this Truck Lane sign means, as parking is prohibited along Coode Road. The kerbside lane is used for slow moving trucks as they queue to enter the port.	LOW

<ul style="list-style-type: none"> - Review the need for the Truck Lane sign as part of the overall parking review. 	Agreed

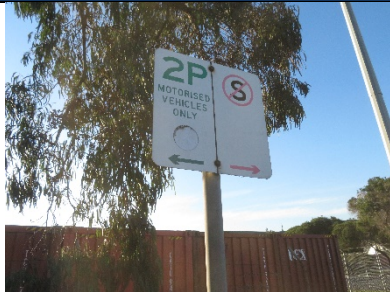
NO.	SAFETY CONCERN	RISK	PHOTO	RECOMMENDATION	CLIENT RESPONSE
8	The parking signs need to be reviewed. The sign which states 2P Motorised Vehicles Only is confusing. A motorised vehicle is not defined in the Road Rules and this sign may not be enforceable under the Victorian Road Rules 2009. Does the 2P time limit only apply to "motor vehicles"? Can non-motor vehicles park indefinitely?	LOW

<ul style="list-style-type: none"> - Review the legal interpretation of the parking signs. - Discuss and review the parking prohibitions. - Set objectives for how Port Authorities intend to provide efficient parking for trucks into the future. 	Agreed
9	The Stop line across Anderson Road is worn out. It gives little guidance for drivers to know where to stop their vehicle on exiting Anderson Road.	LOW	 	<ul style="list-style-type: none"> - Renew the Stop line marking. - Also renew all the line marking along Appleton Dock Road and Anderson Road. 	Agreed

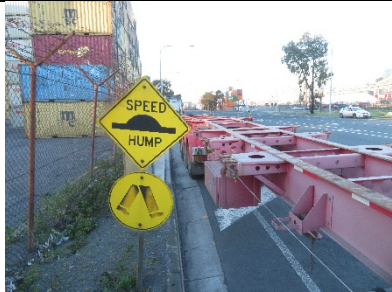
NO.	SAFETY CONCERN	RISK	PHOTO	RECOMMENDATION	CLIENT RESPONSE
11	There are no road humps on Appleton Dock Road. This top sign is redundant and should be removed. Similarly, there are no Pedestrian Crossings on this road and this regulatory sign (below) is unnecessary. It should also be removed.	LOW

- Remove these redundant signs.	Agreed
12	This sign is clearly not serving any practical use. Unless effective parking enforcement does take place, these types of signs should be removed.	VERY LOW

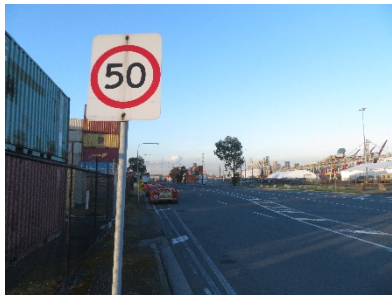
- After the parking issue is reviewed, remove this sign.	Agreed
13	There are several 50km/h speed restriction signs in the area. This is reinforcing the urban speed limit. It is worth considering a 40km/h limit, not because of existing high speeds but more to bring consistency into the area and to recognise that trucks are operating often at lower speed. Shopping streets, schools and some suburban areas have 40km/h speed zones. Such an area wide speed limit is appropriate for the port area too.	LOW

- Introduce a 40km/h area wide speed limit through the port area.	Agreed

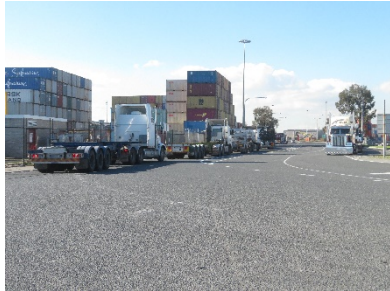
NO.	SAFETY CONCERN	RISK	PHOTO	RECOMMENDATION	CLIENT RESPONSE
14	At 3pm on the day of the inspection, there was a long queue of double parked trucks along the western side of Appleton Dock Road. This reduced the width of the road to a single northbound lane. If this was taking place in an area of many pedestrians or many other small motor vehicles this could present a significant road safety risk. On this road, it indicates a need for a review of parking. The review should check that all parking restrictions are practical, realistic and easy to understand. They must conform to the Road Rules Victoria so they are enforceable.	LOW

<ul style="list-style-type: none"> - Review the parking provisions along Appleton Dock Road and other port roads. - Ensure that the existing parking restriction signs conform to the Road Rules Victoria. - Consider developing an ability for trucks to “double park” while waiting for access to the port. - If a central median is constructed in Appleton Dock Road, locate the median so that double parking of trucks (if required) is able to take place at busy times. 	<p>Agreed.</p> <p>Agreed.</p> <p>Double parking will not be permitted anywhere on port roads as this behaviour promotes the unintended consequence of the behaviour being replicated elsewhere.</p> <p>Double parking will not be permitted anywhere on port roads as this behaviour promotes the unintended consequence of the behaviour being replicated elsewhere.</p>
