IN THE CORONERS COURT
OF VICTORIA
AT MELBOURNE

FINDING INTO DEATH WITH INQUEST

CONTACT - SHOCK

158 CITY Road

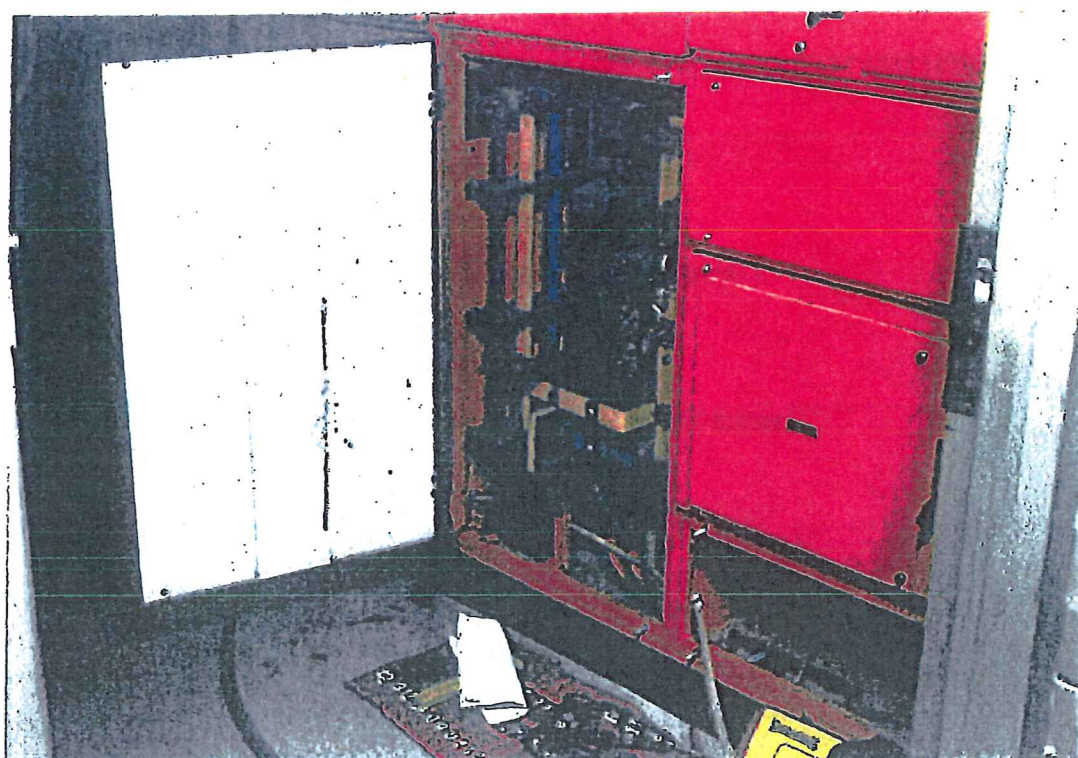
A closer examination of the area, it was noticed that a 70mm sq insulated earth conductor was installed from a penetration through the west wall and the entering the switchboard via the top of the left cable way, it then entered the left side of the CT chamber and exited via the right side to the compartment locating the earth bar. Excess earth conductor was laying on the floor and out the access door. (refer photo 1)

Photo 1. This image is of the view of Switch room looking from east door.

Compliance officers observed that there were a number of options to get the earth conductor to the earth bar without running it in the CT chamber. The earthing conductor could have been run on the cable tray located on top of the switchboard and down the cable riser located on the right hand side of the board.

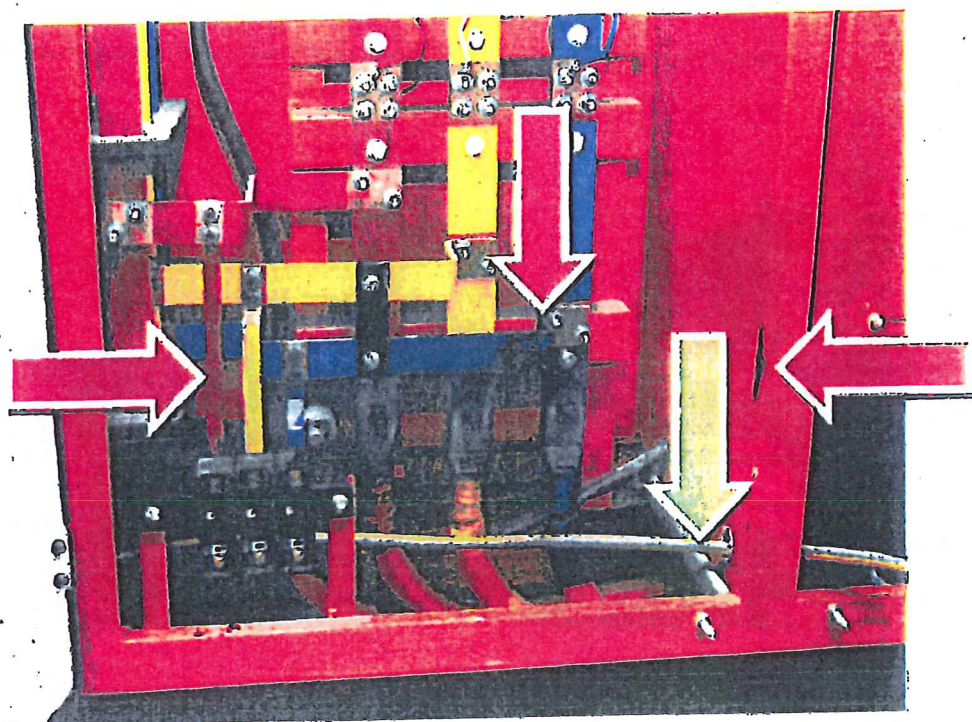
Daryl Taylor and I then conducted a close inspection of the CT chamber and noted that Red and Yellow bar from the existing CT fuses had arc marks on them (refer photo 3). The Red, Yellow and Blue incoming supply bars had arc marks located on the connection bolts that connected the cables to the bars. There was also an arc mark on the right hand side of the CT chamber. (refer photo 2) The CT chamber was not isolated by the unmetered main switch that was locked off (refer photo 5).

A small 1.2m. fiberglass step ladder located outside the room had arc marks on the aluminum top cap. The arc marks on the top cap were consistent with distance between the marks on the right hand side of the CT chamber and the connection bolts. Christopher Elliot's statement to Police confirmed that the ladder was used to remove Dwayne Robertson from the electrical supply by jamming it between the bus bars and the victim (refer photo 2 and 4).

Photo 2. This image shows the Earth conductor passing through the CT chamber and the arc marks on bus bars and frame of CT chamber and earth conductor that was installed. Red arrows indicate location of arc marks and green arrow indicates earth conductor.

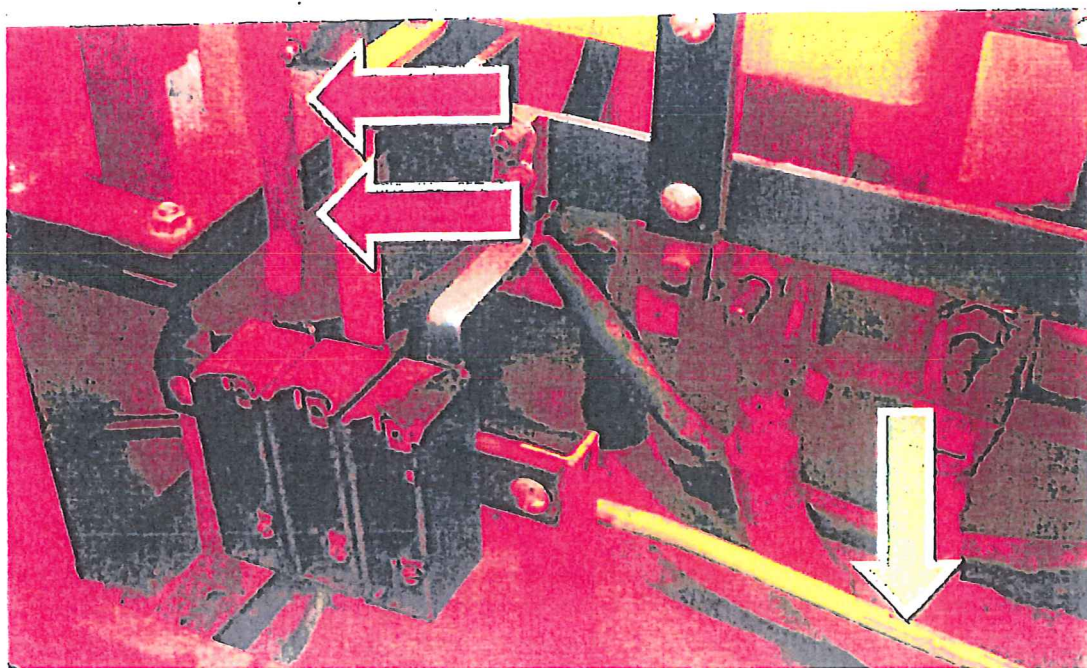
Photo 3. This image shows arc marks on bus bar supplying CT fuses. Red arrows indicate location of arc marks and green arrow indicates earth conductor.

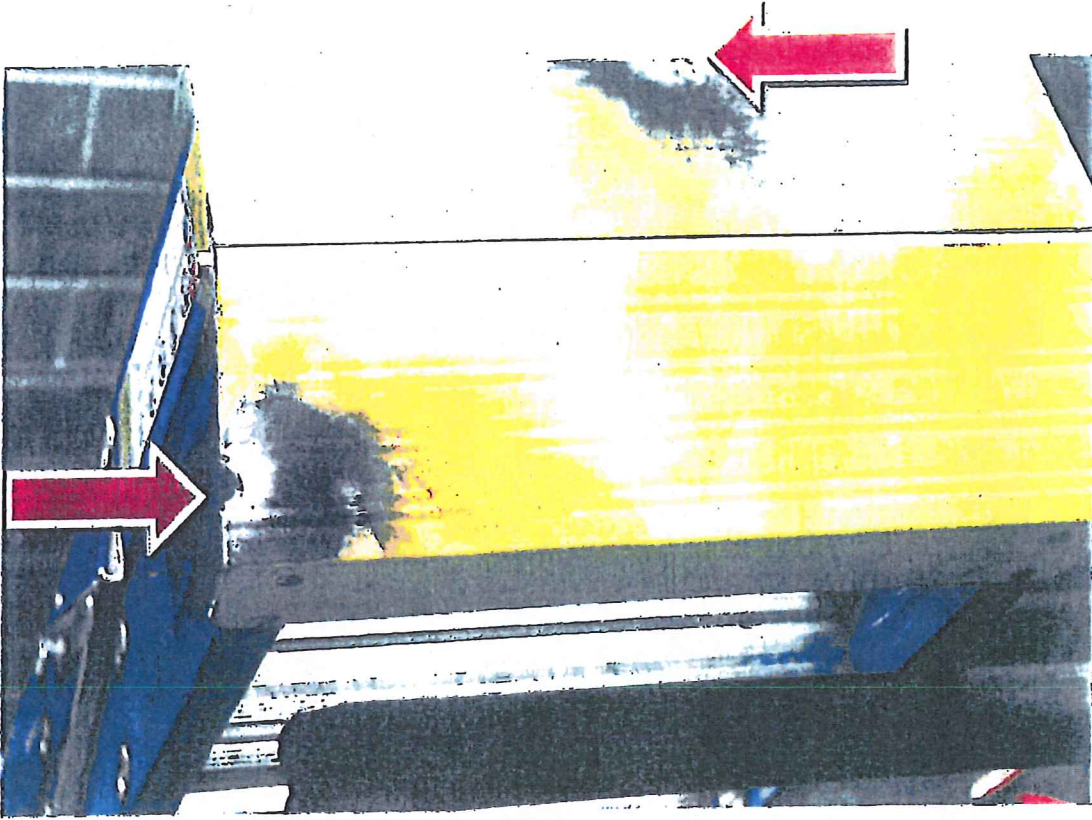
The electrical supply was isolated by jamming the aluminum top plate of a 1.2m fiberglass ladder between the victim and the live parts. This ruptured the protection fuses in the substation isolating supply.

Photo 4. This image shows the arc marks on the aluminum top cap of the ladders. Red arrows indicate location of arc marks.

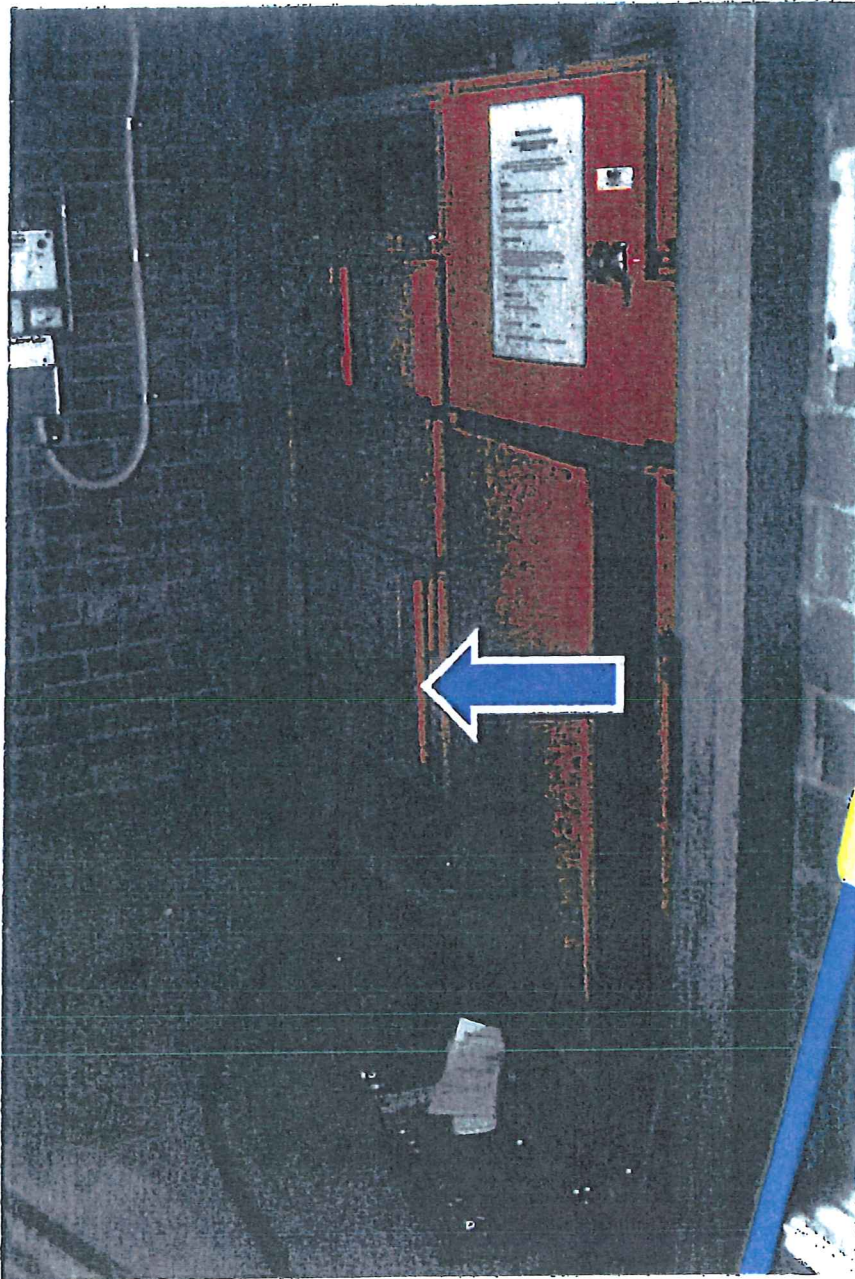
I then inspected the unmetered riser main switch and noted that it had a distribution company lock on it and it was in the off position (Photo 5). No danger tags were located on the main switch.

Photo 5. This image shows the locked off main switch (bottom left). Blue arrow show locked main switch.
