IN THE CORONERS COURT
OF VICTORIA
AT MELBOURNE

FINDING INTO DEATH WITHOUT INQUEST

Deceased: Frances Jeyann Ramirez

Key words: Pedestrian fatality, inadequate streetlighting

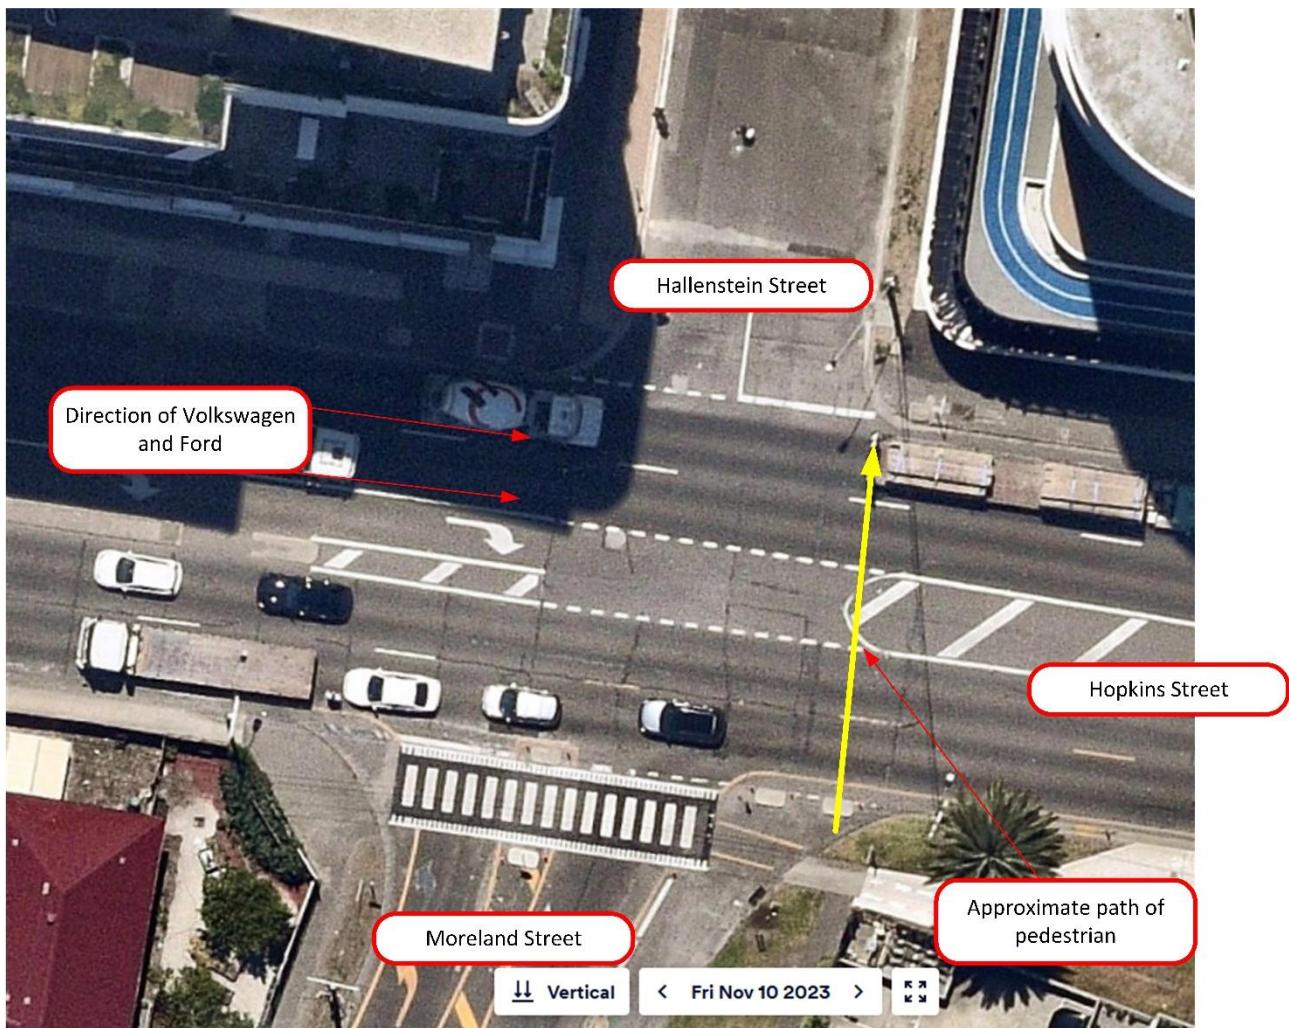
Picture 1: Depiction of the relevant intersection

23. The closest intersection to the place where Ms Ramirez began crossing Hopkins Street was the Hallenstein/Moreland Streets intersection with Hopkins Street where there was no pedestrian crossing or traffic lights. This intersection is about 120 to 130 metres from both Whitehall Street and Joseph Road.

39. Moreover, travelling east on Hopkins Street, through the Whitehall Street intersection and towards Hallenstein Street, the roadway slopes up towards a crest entirely obscuring the drivers’ view of Ms Ramirez for some distance before levelling out shortly before the Hallenstein/Moreland Street intersection where the incident occurred.
