IN THE CORONERS COURT  
OF VICTORIA  
AT MELBOURNE

Court Reference: COR 2023 006881

**FINDING INTO DEATH WITHOUT INQUEST**

| Place of death: | North Shore Road railway crossing, North Shore, Victoria |

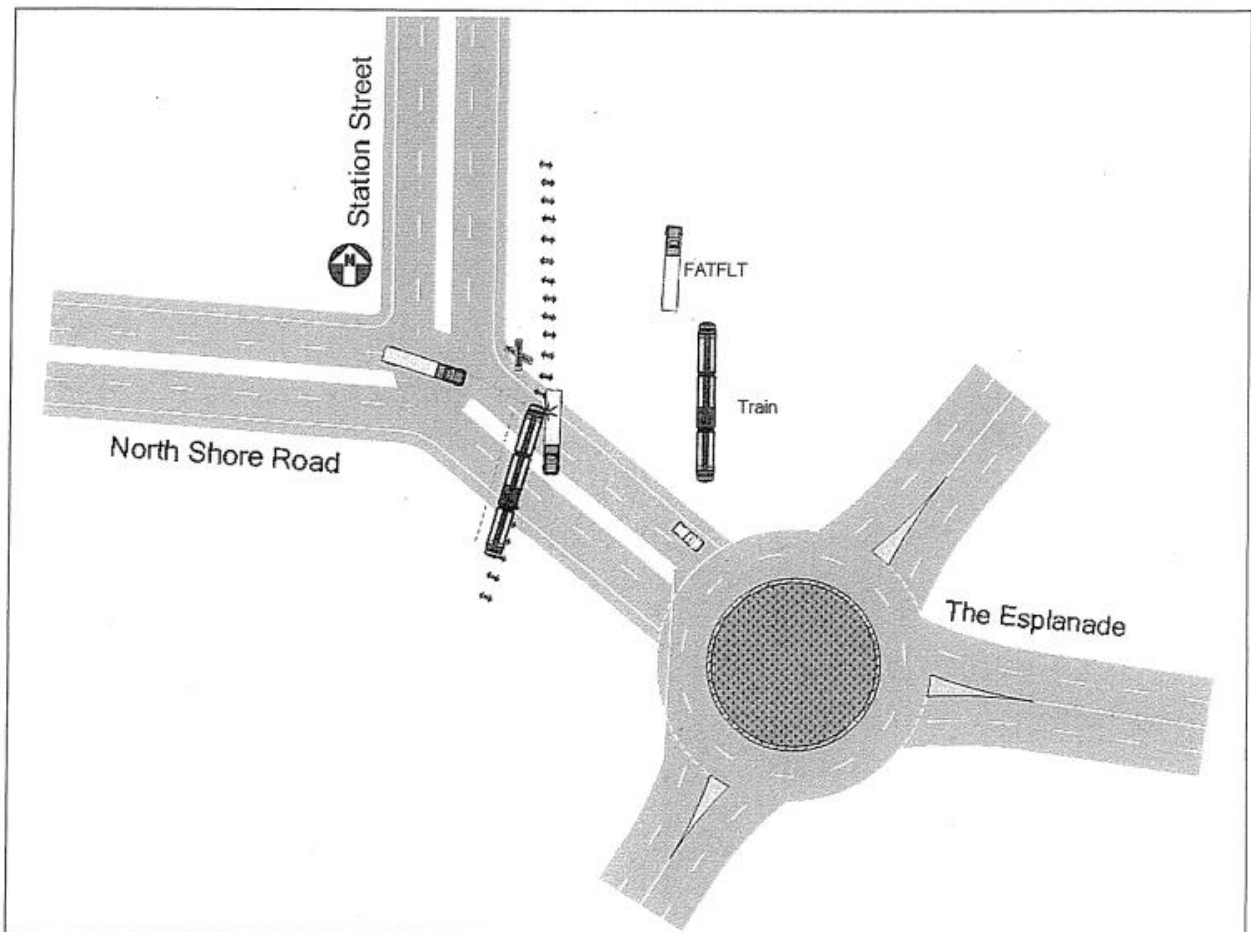
31. In accordance with routine practice, the train driver was tested for alcohol and illicit drugs and returned negative results for both.
32. According to Leading Senior Constable Robert Nuske, Coronial Investigator, the North Shore Road level crossing has a 7.5 percent gradient (about 200 millimetres) over a nine-metre width of road bitumen. He noted that the level crossing is part of the Regional Rail Revival Project. As at the date of the collision, improvements of the level crossing had been proposed in the near future. Leading Senior Constable Nuske also noted that there had been multiple incidents at the level crossing since 2017, which mainly involved vehicles, including heavy vehicles, colliding with the railway infrastructure.

Picture 1: Depiction of the level crossing and adjacent intersections

was due to Mr Stubbs being unaware of the gradient slope of the level and how it would impact his journey.

1. That as a matter of urgency, the City of Greater Geelong and/or the Department of Transport and Planning collaboratively plan for and install additional road signage on all approaches to the North Shore Road level crossing forewarning drivers of the problematic gradient ahead and allowing them to adjust their hydraulics or seek an alternative route.
