IN THE CORONERS COURT
OF VICTORIA
AT MELBOURNE

FINDING INTO DEATH WITH INQUEST

CONTACT - SHOCK

158 CITY Road

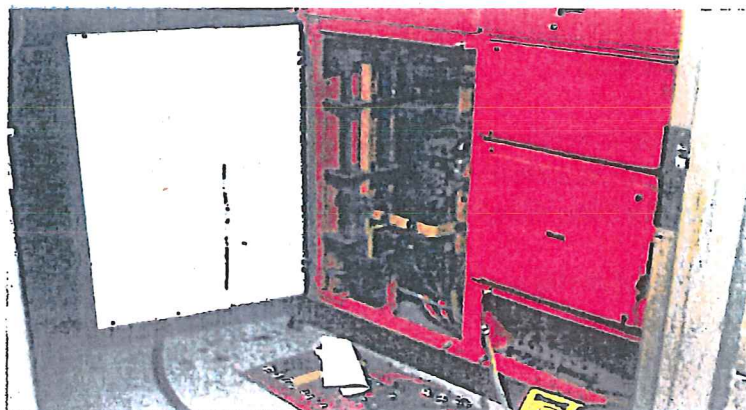
The incident occurred in the Main Switchboard Room, located at the rear of the mezzanine floor of Hanover House, a six story office building.
